FINAL REPORT

PROTECTIVE COATINGS FOR CHROMIUM ALLOYS

NATIONAL AERONAUTICS AND SPACE ADMINISTRATION

CONTRACT NAS 3-7273

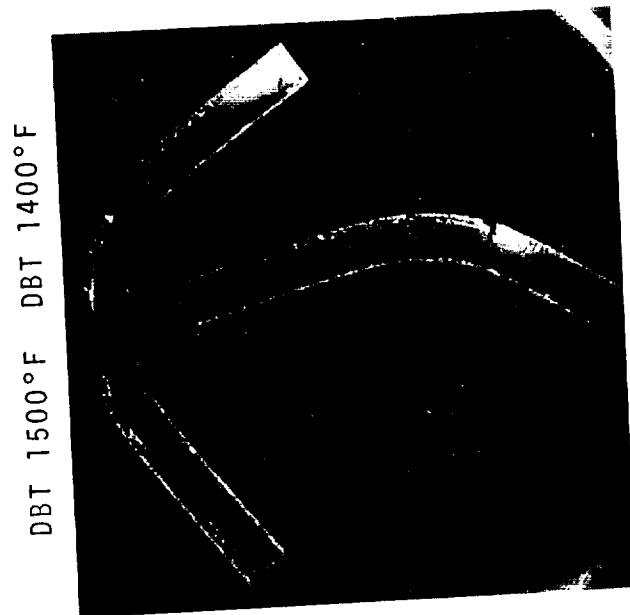
FIGURE 3-43
2 ϕ COATED Cr-5W-Y DBTT SPECIMEN AFTER 10 HOURS AT 2400°F IN ARGON. NOTE
EDGE CRACKING PROPAGATING FROM COATING.

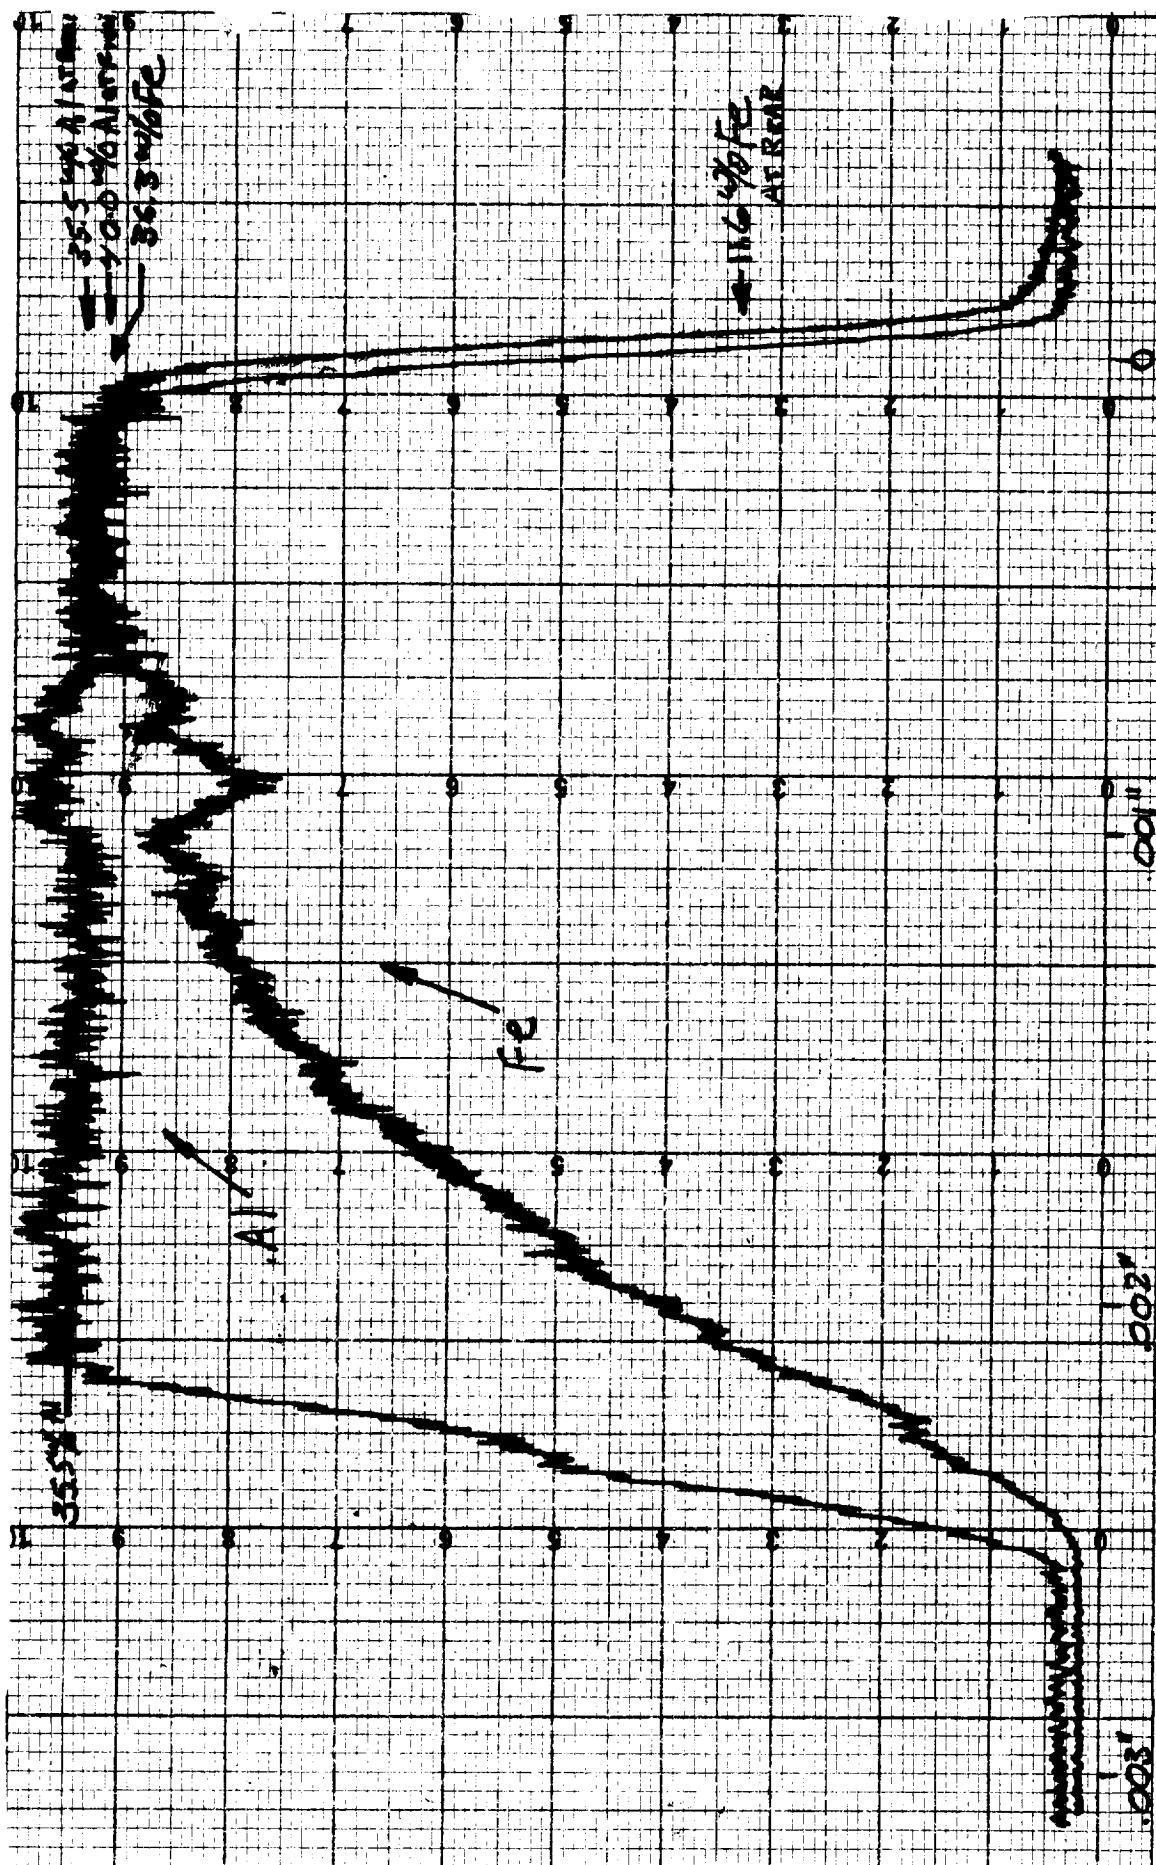
FIGURE 3-94
ELECTRON BEAM MICROPROBE TRAVERSE ON Fe-Al COATED
(20 Type) Cr-5W-Y.
